**RE: BREMERTON AUTO WRECKING LANDFILL/ GORST CREEK LANDFILL
FS ID 62752314**

The Kitsap County Health District (Health District) is writing to inform interested parties of its concerns, recent events, short and long-term goals, and some options for cleanup at the Bremerton Auto Wrecking Landfill/Gorst Creek Landfill (landfill).

Summary of recent slide

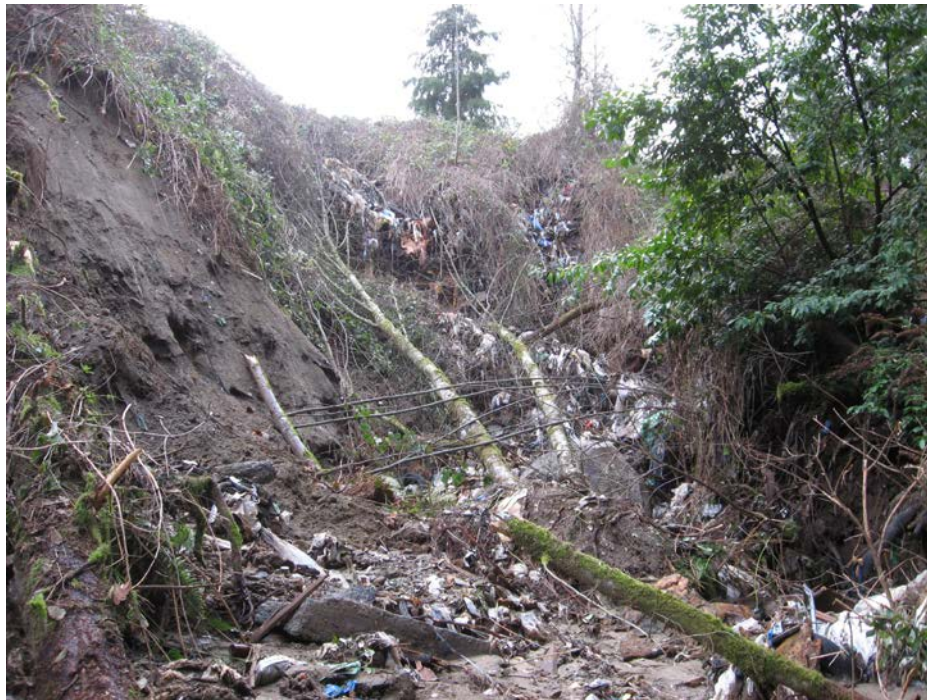
On December 3, 2007, the Bremerton, Washington area received 10" + of rain. On December 4, 2007, staff from the Health District inspected the northwest face of the Bremerton Auto Wrecking Landfill/Gorst Creek Landfill. The inspectors found that approximately 50 to 200 cubic yards of waste, debris, and soil had slid off the face and into Gorst Creek. Waste from the landfill was scattered at least ½ mile downstream of the face. A rock weir installed by Washington State Department of Transportation (DOT) in 1997 was washed away. The concrete culvert under State Hwy 3 was partially blocked by debris.

The photo above shows part of the slide area on the northwest face of the landfill.

- a) Stabilize the face of the landfill so that it does not slide into the creek
- b) Clean up the existing waste in the creek.

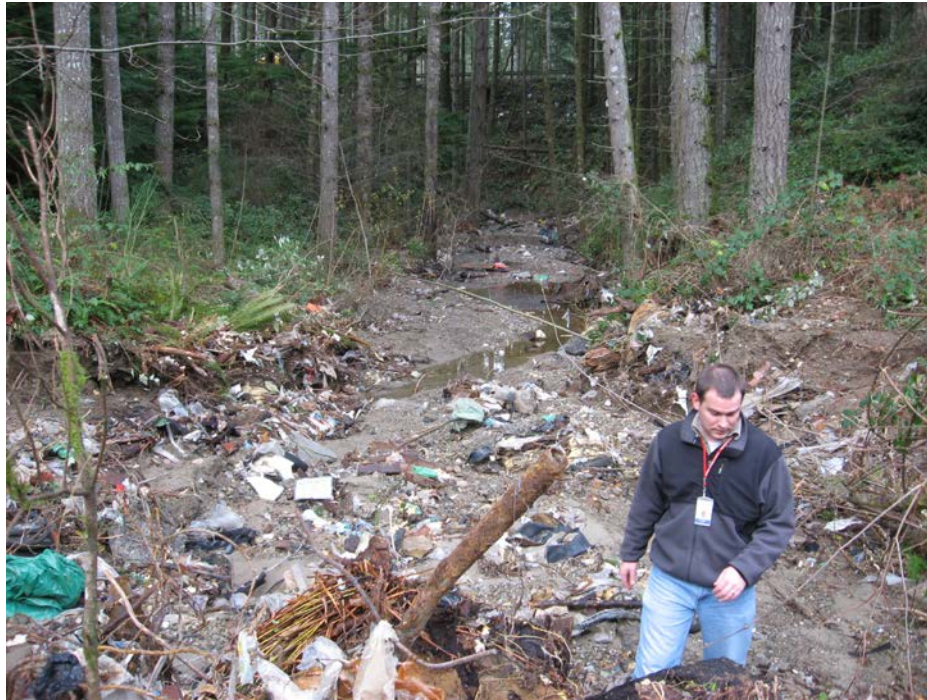
This photo shows the Gorst Creek stream channel from the northwest face to State Hwy 3.

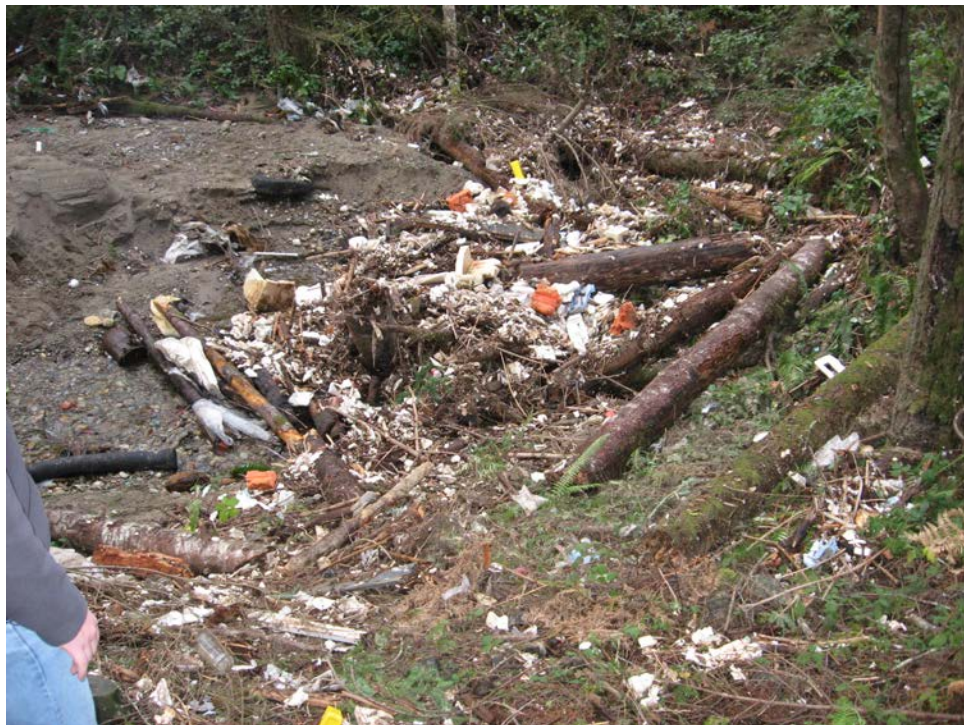
The photo above shows the partial blockage of the concrete culvert under State Highway 3.
This material has since been removed by DOT.

The Health District was contacted by the DOT after the slide. DOT used an excavator to remove the debris from in front of the road culvert and placed it 20 feet away.

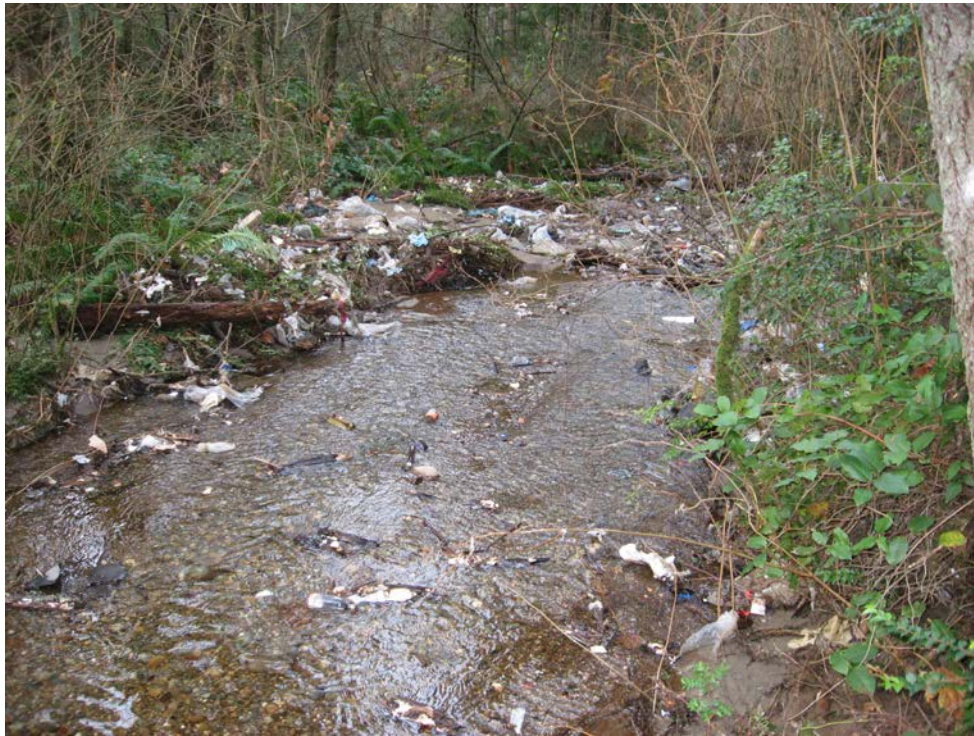
Gorst Creek below (northwest) State Highway 3. Note the debris from the landfill. This is approximately 200 yards below the slid landfill face and 100 yards below State Highway 3.

The Health District has been in contact with the City of Bremerton about picking up the waste in the stream below the highway. The City has already cleared the access road that leads down to the stream.

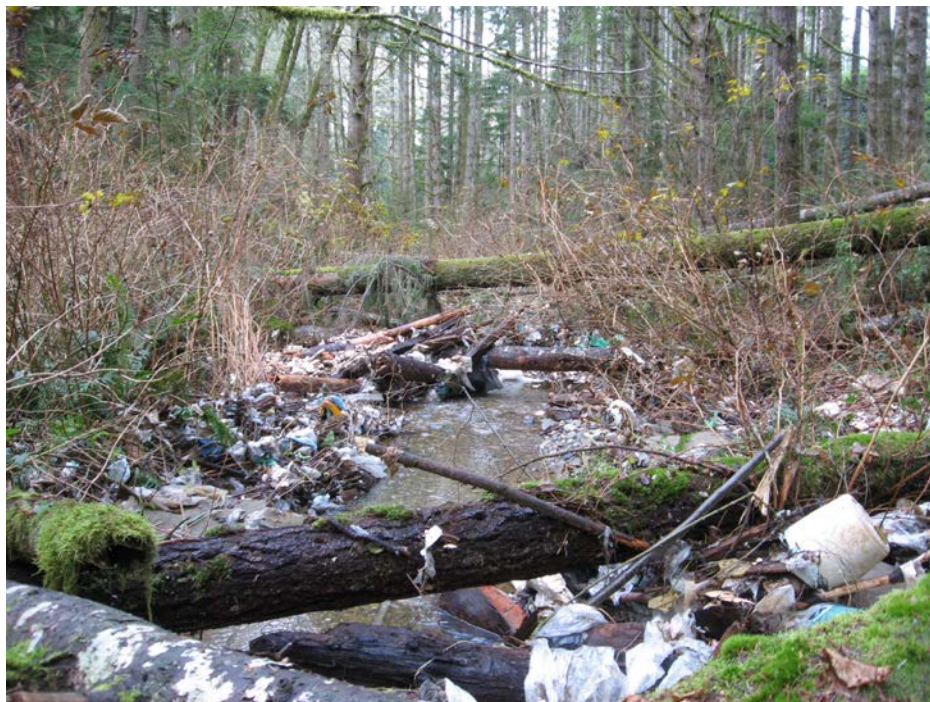
Gorst Creek below State Highway 3.
